Zhouqu, Gansu, China
Debris Flow

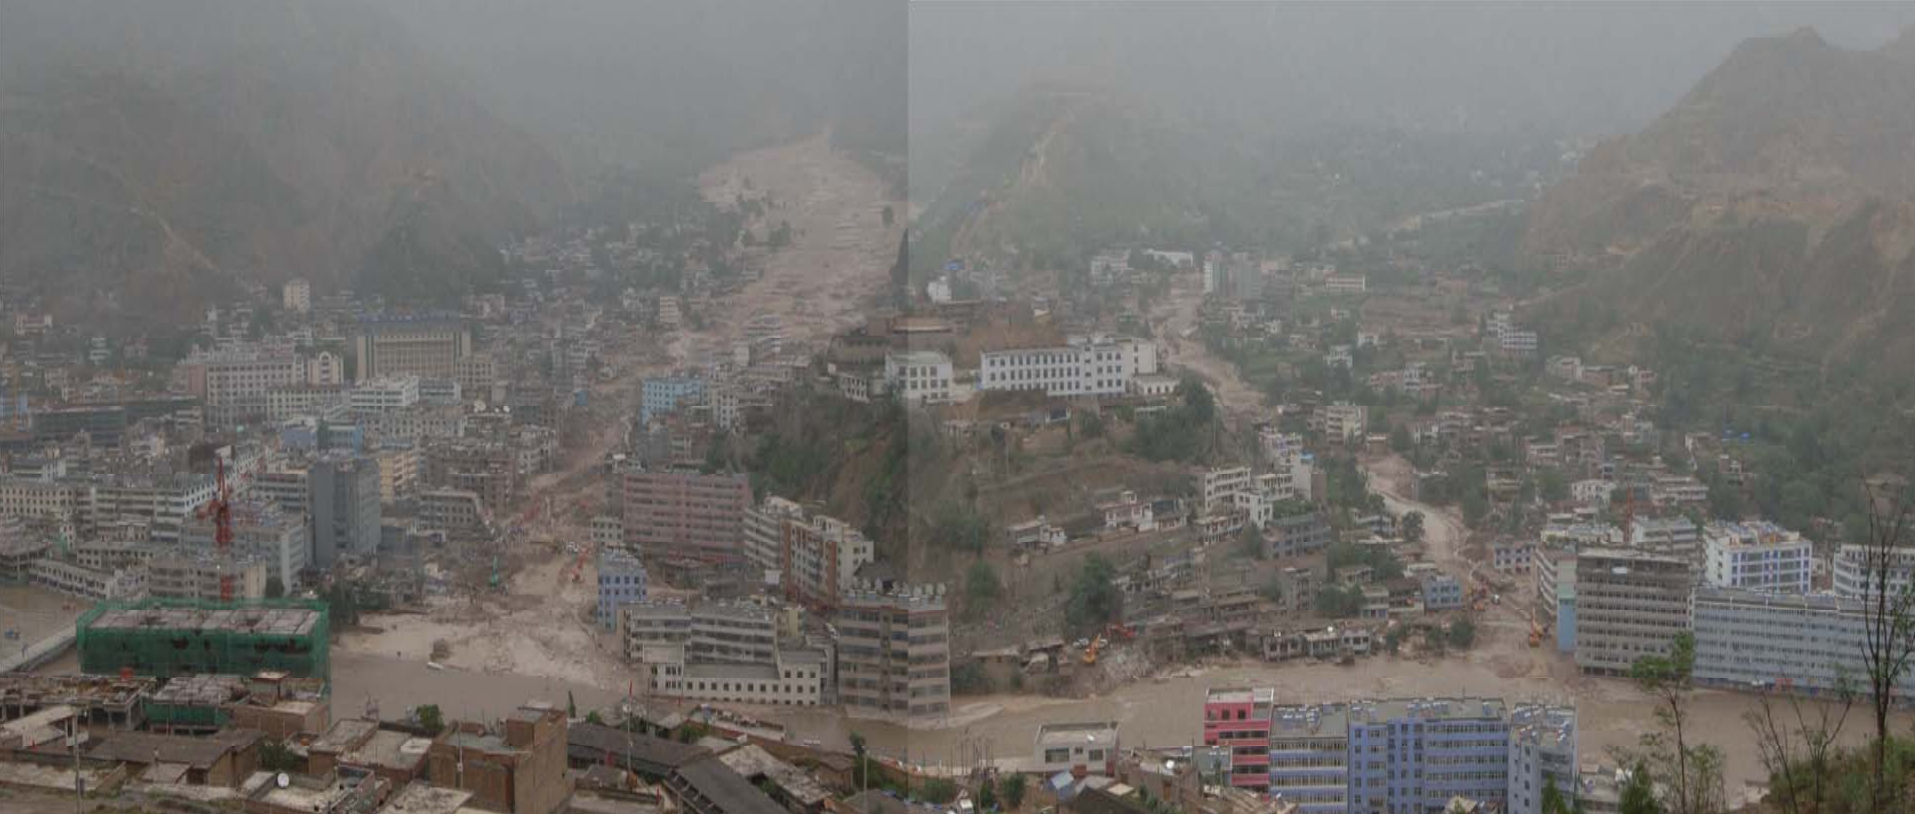
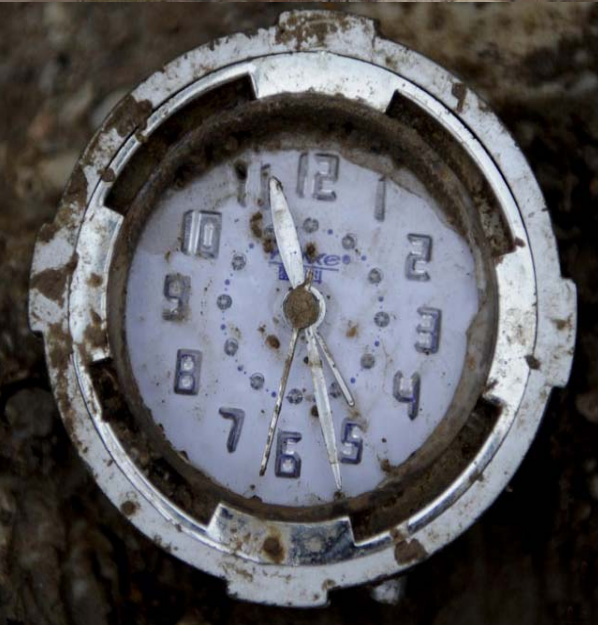
Debris flows at Sanyanyu Gully (left) and Luojiayu Gully (right) occurred in the night of 7th August, buried the farms, destroyed the houses, made great casualties, rushed into Bailong River and formed a dammed lake which submerged the main street of the city.

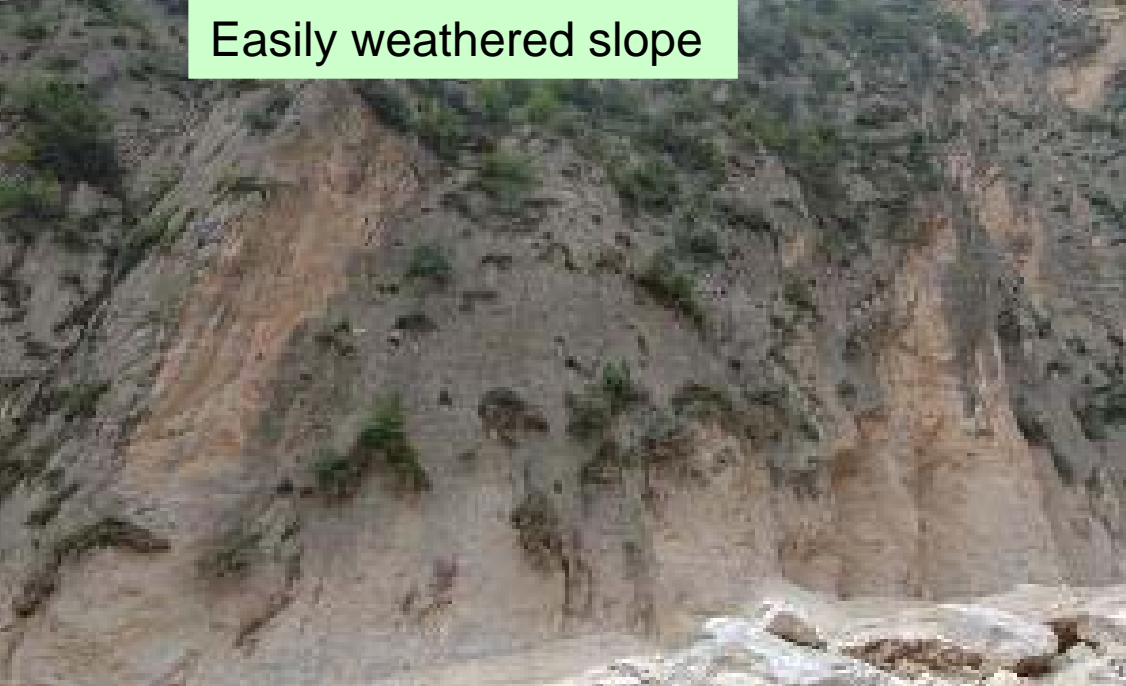
Easily weathered slope

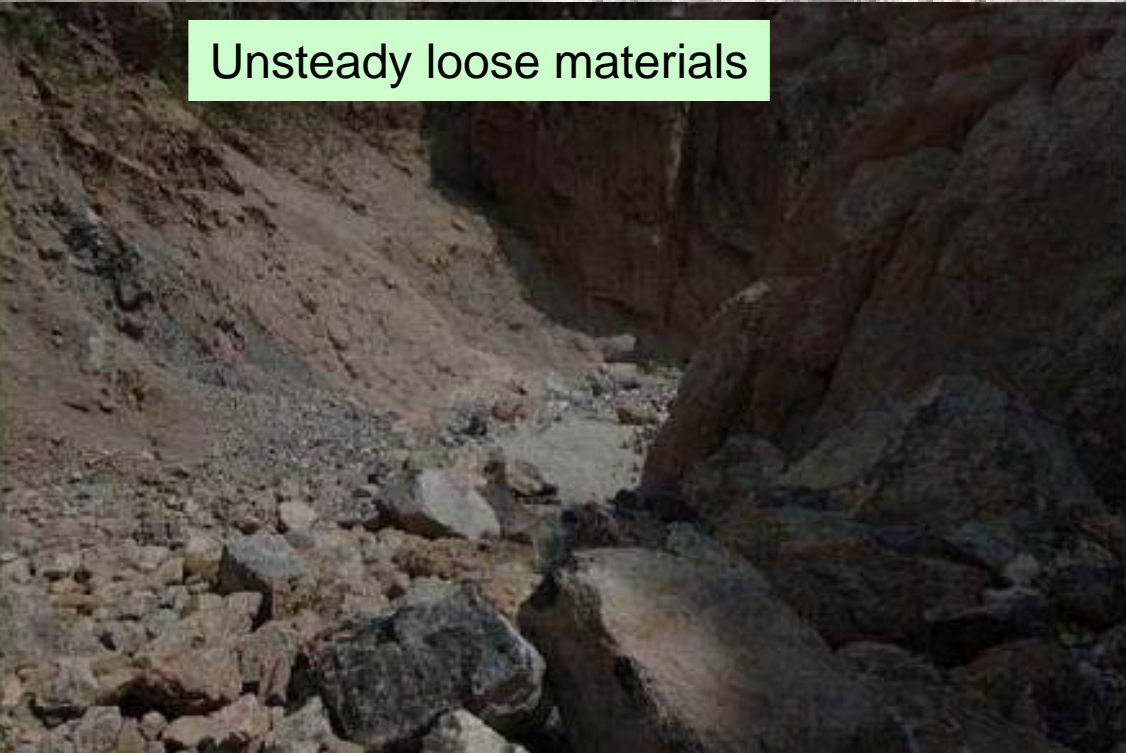
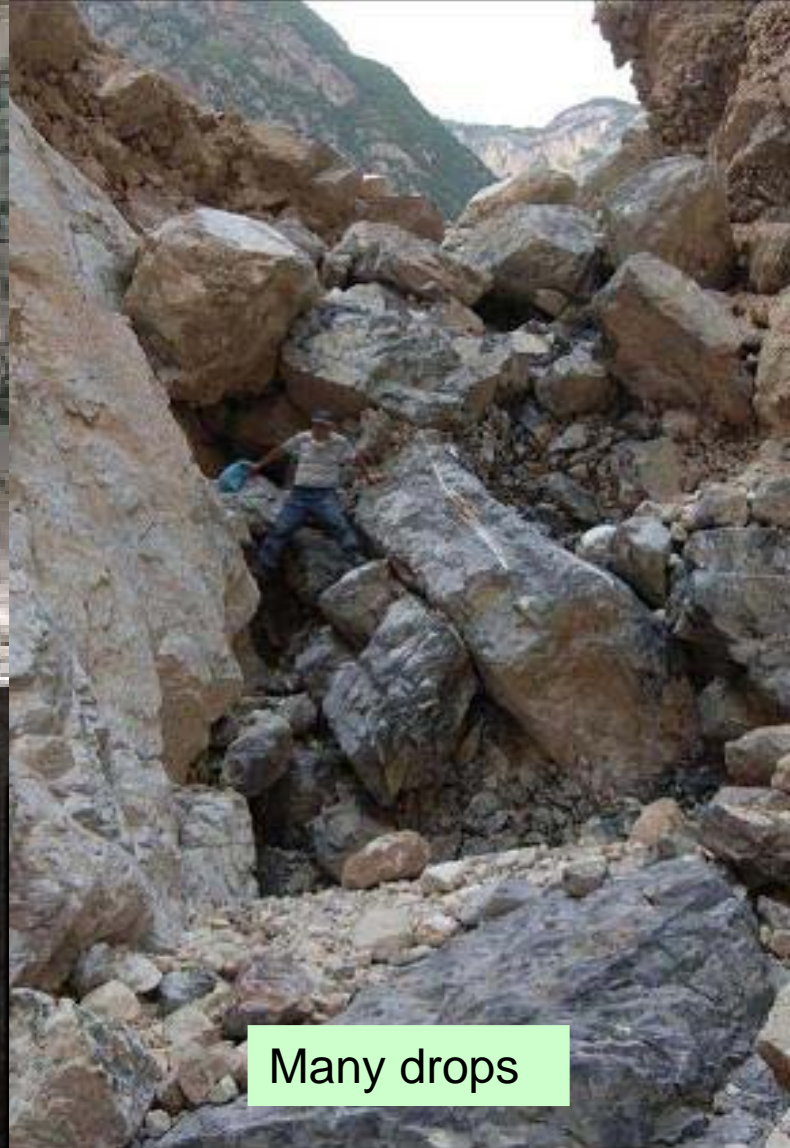
Unsteady loose materials

Many drops

During the rainfall, the local geomorphology creates a good condition for debris flow starting

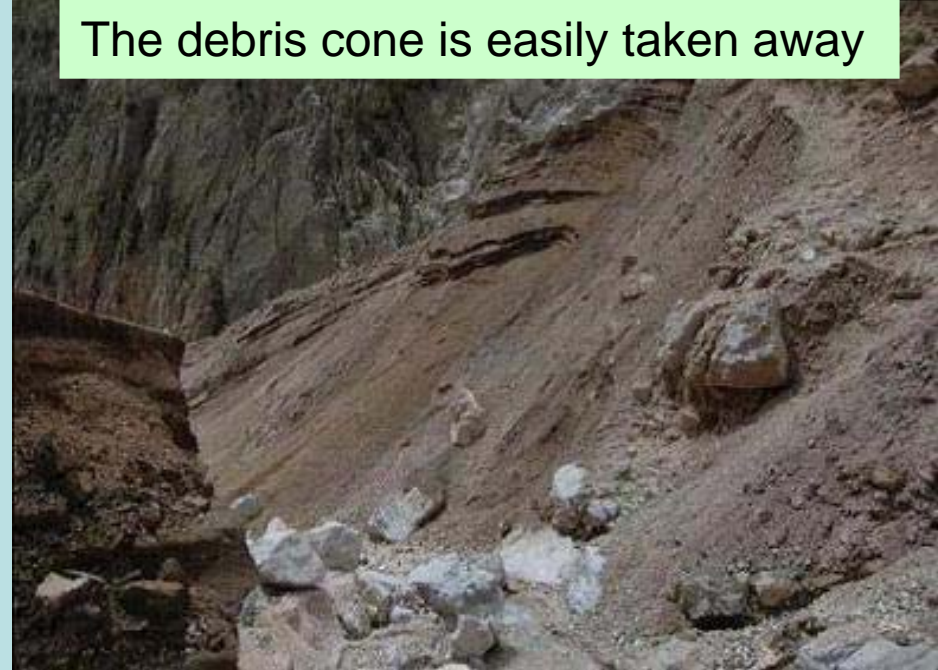
The debris cone is easily taken away

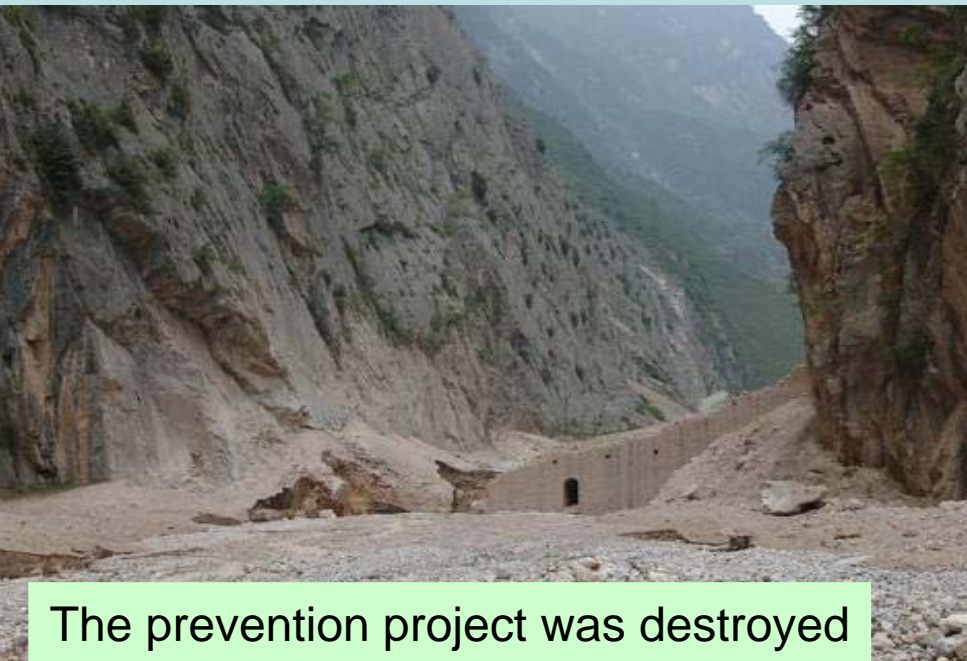
The prevention project was destroyed
